Re: January 2013 Monthly Progress Report
Administrative Settlement Agreement and Order on Consent for Removal Action
U.S. EPA Region 10 Docket No. CERCLA 10-2009-0255
Gasco Sediments Site within the Portland Harbor Superfund Site

Attachment A Monthly Visual Monitoring Report for Pilot Cap Vicinity

Visual Observations Log Form

Monitoring Period: Monthly (Year 7)—January 2013

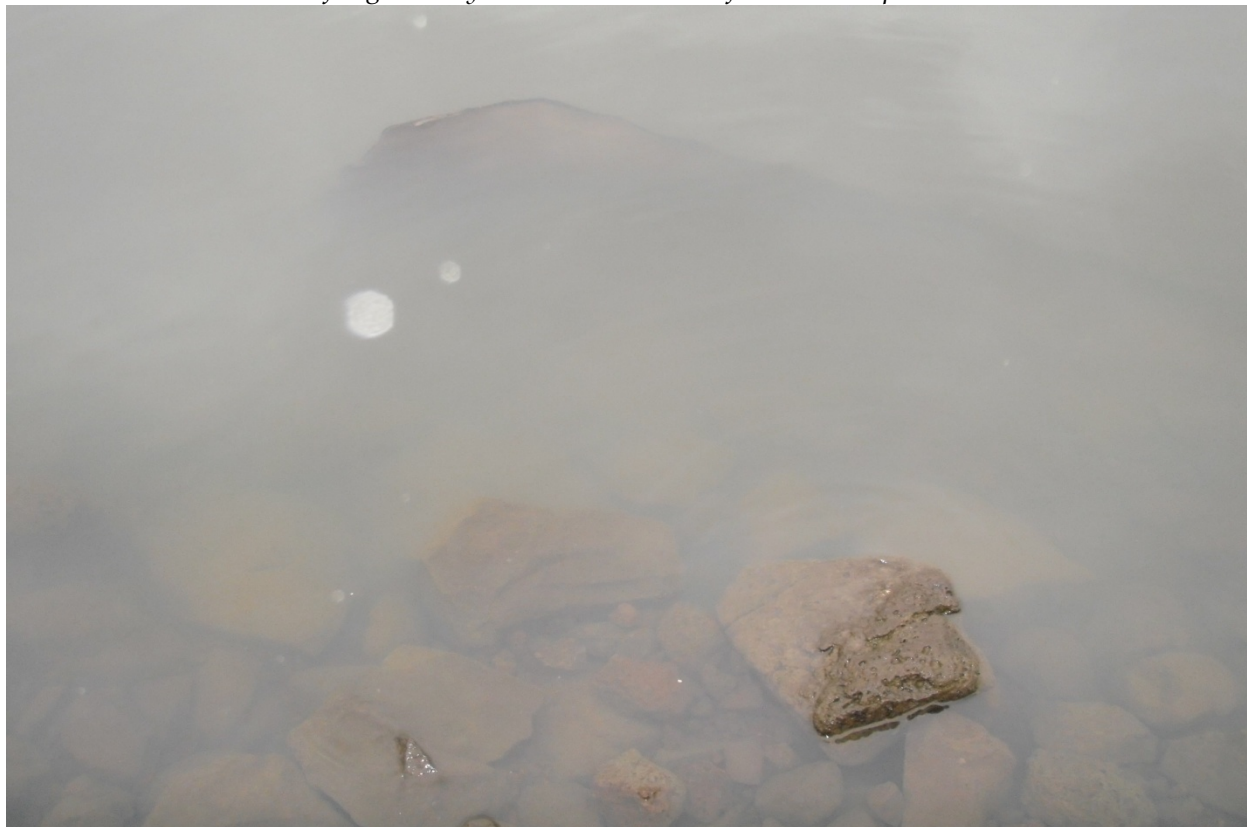
Observations of Erosion/Deposition: No erosion/deposition is evident along the shoreline. One exposed organoclay mat segment was visible approximately 4 feet from the waterline approximately halfway between the upriver and downriver extents of the cap. Other known segments of exposed organoclay mat were submerged and not visible at this river elevation (Photo 1).

Photo 1 — *Visible section of organo-clay mat at mid-section of sediment cap (1/29/13):*

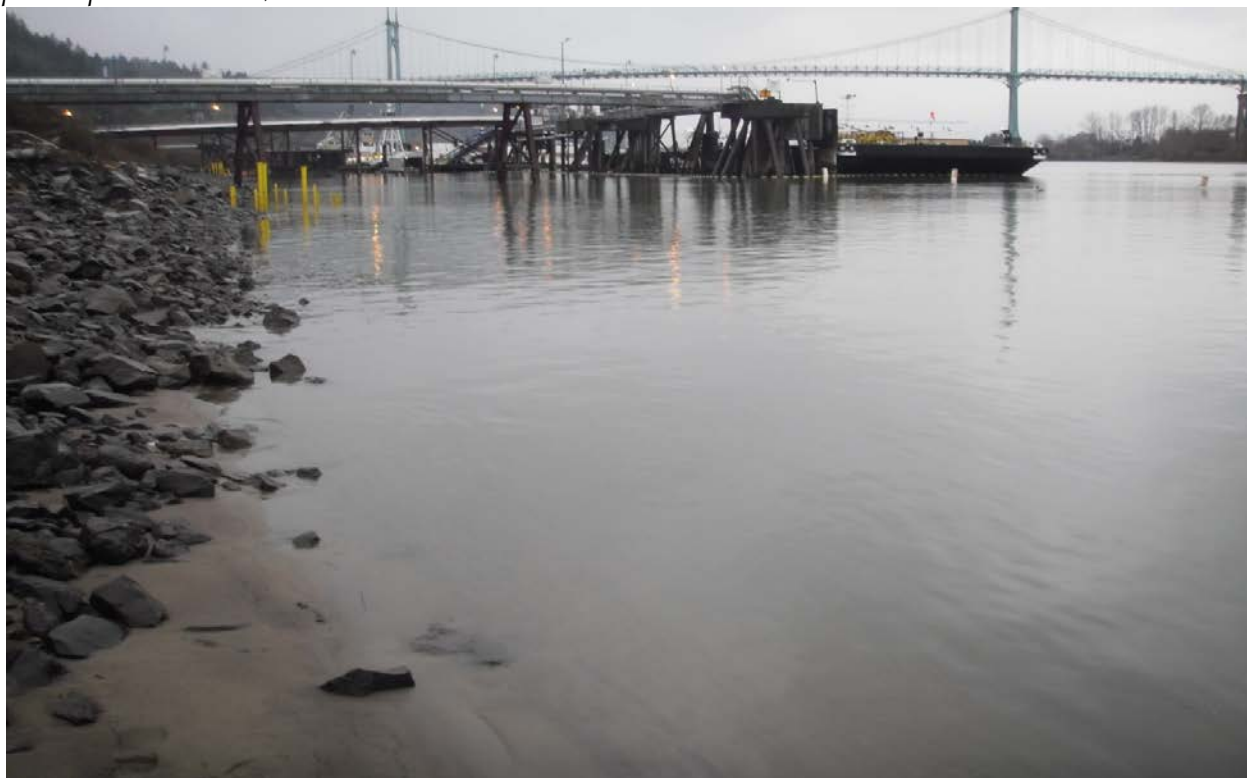
Observations of Long-term Controls (i.e., oil booms, organo-clay mat, etc.) During the observation, the Fuel and Marine Marketing (FAMM) containment boom was placed around a refueling barge at the FAMM ship dock. Buoys that identify the cap area to mariners are in place as installed. The position of the FAMM oil boom, warning buoys, and a general overview of the site shoreline is shown in Photo 2.

Photo 2 — *FAMM oil boom shown around barge tied to pier and mariner warning buoys in place across pilot cap area. 1/29/13):*

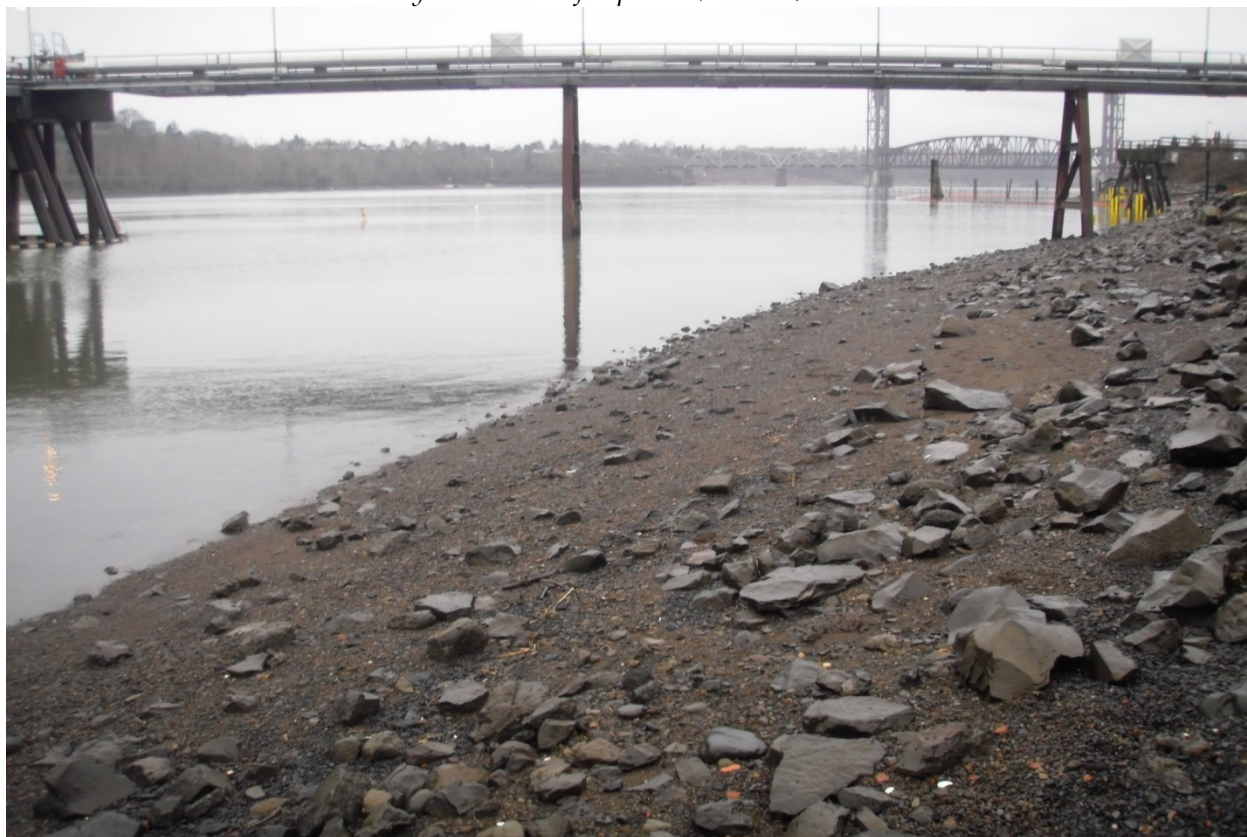
Other Comments: No sheen is evident in or around the cap area. Photo 3 shows the water surface and shoreline immediately downriver of the sediment cap.

Photo 3 — *Conditions immediately downriver of cap area (1/29/13):*
